# 9<sup>th</sup> Avenue Pond, Lethbridge, Canada

Application dates: Seven applications from April 24<sup>th</sup> 2014 to October 23<sup>rd</sup> 2014

**Aim:** Reduction of the phosphorus loading within the the pond to reduce excessive growth of filamentous algae.

**Description:** Industrial stormwater management facility.

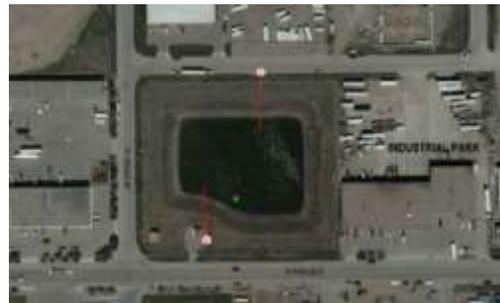
Figure 2 : Aerial photo of 9<sup>th</sup> Avenue pond showing the sampling points.

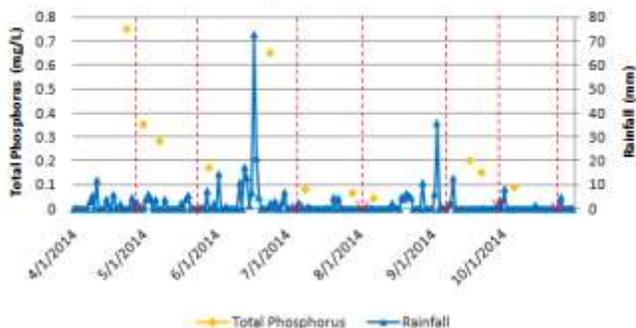
**Total Phosphorus vs. Rainfall**

Water data was collected from within the pond with the results displayed in Figures 3,4 and 5. Data plotted in the total phosphorus (TP) and orthophosphate graphs show that there was a significant reduction in the phosphorus concentrations in the pond after the applications of Phoslock. There was an

increase in these concentrations after the high rainfall event, however the TP and orthophosphate concentrations dropped rapidly to very low concentrations after the event. This shows that even when there was a major influx of phosphorus entering the pond in runoff, the Phoslock was able to rapidly bind it and remove it

Figure 3: The total phosphorus concentrations verses rainfall over time in 9<sup>th</sup> Avenue pond (Phoslock doses are marked with red dotted lines).

from the water column. Hence, being unavailable for utilization by algae. Continual small applications of Phoslock were able to keep the phosphorus concentrations low in the storm water pond over time.

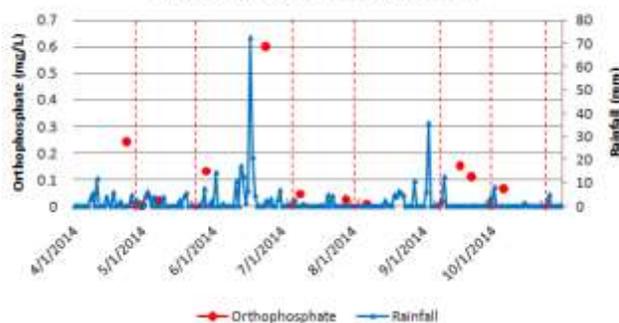
**Orthophosphate vs. Rainfall**

Figure 4: The orthophosphate concentrations verses rainfall over time in 9<sup>th</sup> Avenue pond (Phoslock doses are marked with red dotted lines).

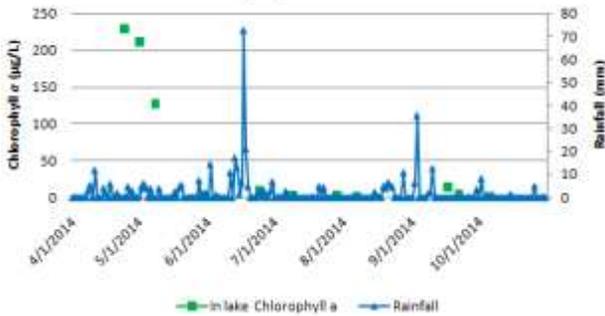
**Chlorophyll *a* vs. Rainfall**

Figure 5: The chlorophyll *a* concentrations versus rainfall over time in 9<sup>th</sup> Avenue pond.

The concentration of chlorophyll *a* significantly decreased after the application of Phoslock on April 24<sup>th</sup> 2014 (as seen in Figure 5) and continued to remain low over the duration of the application period (April-October 2014). Prior to the first Phoslock application, the storm water pond had recurrent blue green algae blooms. The concentration of chlorophyll *a* decreased from 230µg/L to 2µg/L in 2 ½ months and this was even with a heavy rainfall event and a sharp increase in phosphorus in the water in mid June. Chlorophyll *a* has remained around the 2µg/L concentration for the rest of the application/sampling period (to October 2014). The significant reduction in chlorophyll (hence algal load) is highlighted in the before (2013) and after (2014) photos displayed in Figure 6). The ponds water quality and aesthetics has greatly improved with the regular applications of Phoslock to the storm water pond.

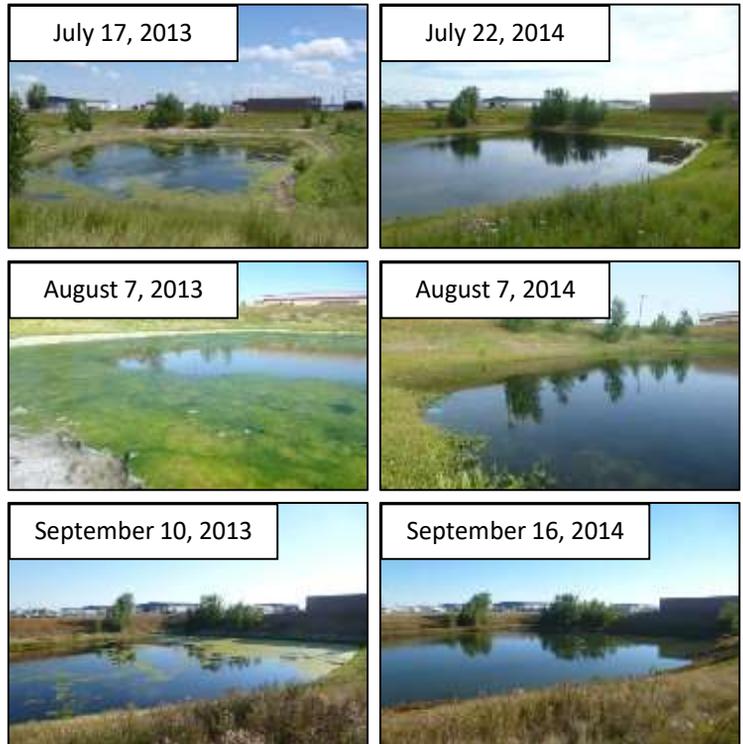
*“In 2012/2013, the 9<sup>th</sup> Avenue storm pond was reported to have intense algal blooms throughout the year; mats of filamentous algae covered significant portions of the ponds water surface. In 2014, approximately a month after treatments began in April, the 9<sup>th</sup> Avenue storm pond water quality began to change. At the beginning of the season algae were present but as each week passed, the amount of algae growing on the surface and in the water column decreased. Together with the decreasing algae growth, the turbidity also*

*improved and water clarity was much greater than 1 meter in depth. The clarity did cause an increase in aquatic vegetation growth however, that was to be expected and not a concern at this pond. Also, aquatic invertebrates seemed to increase in numbers. Each time observations were recorded at the pond there were significant numbers of species around the pond edge and quite often when water samples were taken, invertebrates had to be poured out of the sample. The increase in invertebrates is a relative observation as there were no specific counts made of the invertebrates or the type of species present. “*

Figure 6: Visual differences in the aesthetics and quality of 9<sup>th</sup> Avenue pond before (photos from 2013) and after (photos from 2014) the application of Phoslock.
