Lake Pampulha, Belo Horizonte, Brazil.

Summary

Aim: To bind the soluble phosphorus, reducing the frequency of algal blooms and significantly improving the aesthetics of the water body.

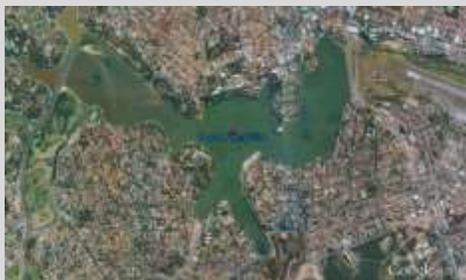
Figure 1: Aerial photo of Lake Pampulha (image from Google Earth Pro, 2017).

Lake Pampulha is a highly eutrophied lake in Belo Horizonte, Brazil. Lake Pampulha was constructed to reduce the effect of flood events and to contribute to the city's water supply. However after many years of receiving organic-laden loads from its river systems, Lake Pampulha has become eutrophied.

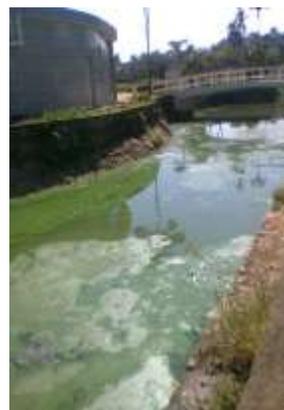
Figure 2: A section of Lake Pampulha prior to the application of Phoslock (Tiago Finkler, 2016).

Prior to the application of Phoslock, Lake Pampulha was classified as highly eutrophic with the mean concentration of Total Phosphorus (TP) measured at 0.70 mg/L of TP.

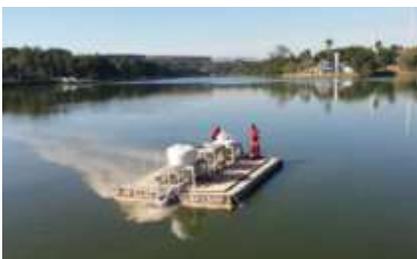
Figure 3: Phoslock application to Lake Pampulha (photo taken by Tiago Finkler, 2016).

The first Phoslock application was undertaken in May 2016. After this, applications were undertaken monthly over the contract period in order to achieve and maintain Class 3 conditions. A sediment curtain was installed in

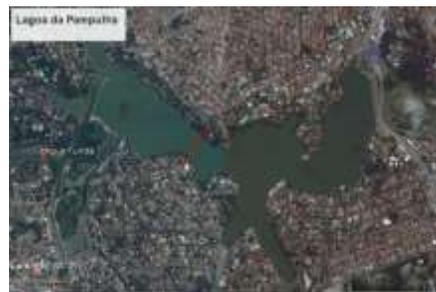
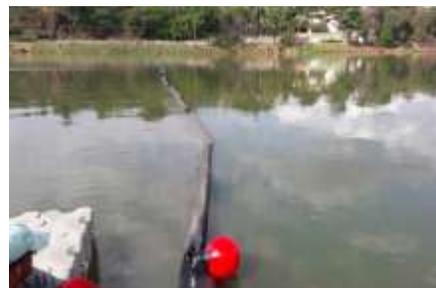
Figure 4: Photos of Lake Pampulha showing the location of the sediment curtain (red line in top photo) and the surface of the curtain in the lake water (Google Earth, modified by Tiago Finkler, 2016).

order to separate the shallow areas from deep areas of the lake and help reduce the nutrient load entering from the main rivers. The curtain is approximately 250 m and made of polypropylene. It allows only the overflow of water to enter, retaining approximately 70 to 80% of solids.

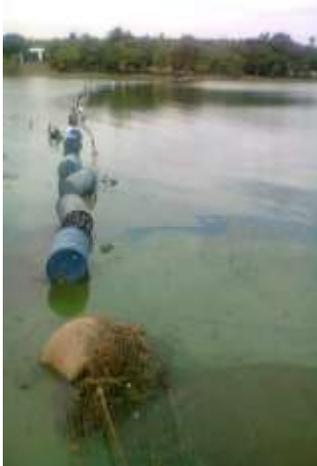
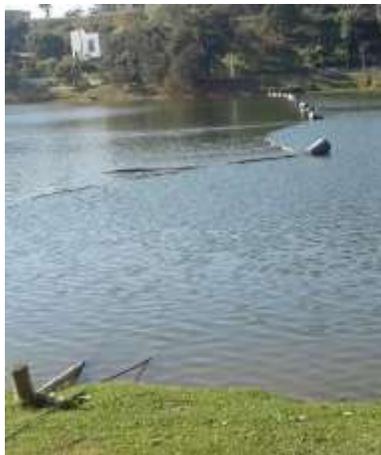
Figure 6: Photos showing the before (April 2016) (LHS) and after (treatment with Phoslock) (July 2016)(RHS) water quality in Lake Pampulha (from Tiago Finkler presentation to NALMS, 2016).
