Reither See, Reith im Alpbachtal, Austria

First application: May 2013 ; small top up applications during spring 2015, 2016, 2017

Summary

Aim: To control the increasing abundance of benthic cyanobacteria/diatom which form floating mats on the water surface.

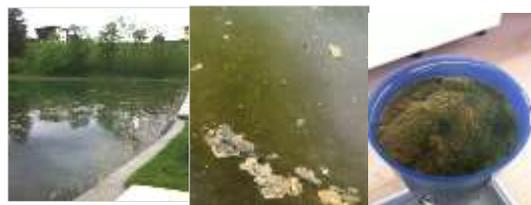
Figure 2: Photos of floating algae mats and benthic algae conglomerates prior to the restoration.

A comprehensive analysis of the water chemistry, phytoplankton abundance, sediment chemistry and benthic organisms was undertaken in order to investigate the causes of the occurrence and proliferation of the benthic algal mats. A dynamic chain of physical, chemical and biological interactions between the water column and the sediment was determined to be the reason for the proliferation of the mats. The crucial factor driving this interaction was the large amount of bioavailable phosphorus in the sediment.

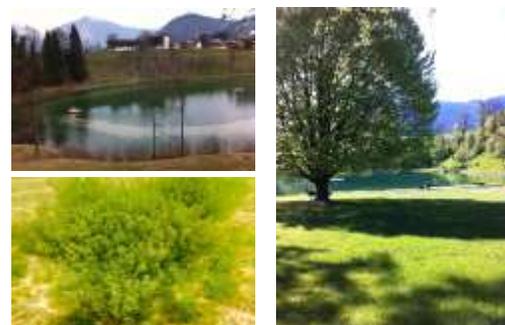
Figure 3: Phoslock application, Charophyte plants, the lake after 3 years of the restoration measures.

In May 2013 an initial application of 6 tonnes of Phoslock was undertaken to bind the "easy-releaseable" P fraction in the upper 5 cm of the sediment. To guarantee an unrestricted recreational use of the lake and to stabilise the improved conditions for the planted charophytes, smaller top up applications of 3.78 and 2.1 tonnes were conducted in spring 2015, 2016 and 2017, respectively.

The two step restoration concept is a technique that prevents the proliferation of benthic algal mats. By locking the easily releasable phosphorus in the sediment creates the conditions necessary for growth of charophyte species, typical for this type of lake. On-going monitoring indicates that the charophytes that have been planted are growing well. Results from the pilot project will be published in a peer reviewed study in preparation (Epe TS., Finsterle K., Pall K., Yasseri S., in prep.)
